Manhole Inspection Summary

Manhole # S13SS_046MH

Insp Date: **9/17/09 10:09 AM**

Location Address: **N DUKELAND ST**

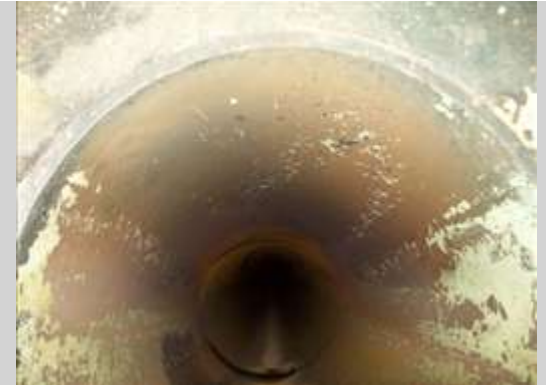
12 O'Clock Outflow

15 in. Circular Gravity Sewer
Pipe Out @ 12 O'Clock

Pipe Material: **PVC** ☐ Pipe Lined

Invert Depth: **4.15** (ft.) Flow Characteristics: **None**

Deposits: ☒ None ☐ Mud ☐ Sludge ☐ Debris ☐ Grease

Infiltration: **None** Pipe Seal Cond: **Sound**

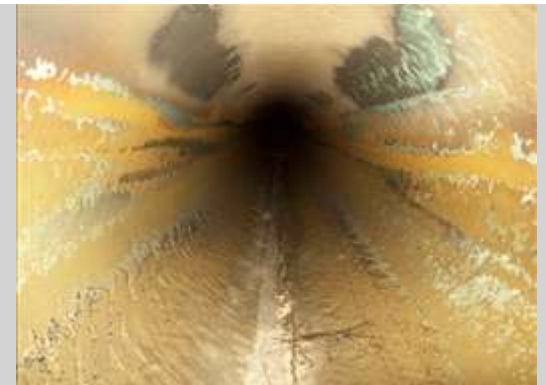
6 O'Clock Inflow

15 in. Circular Gravity Sewer
Pipe In @ 6 O'Clock

Pipe Material: **PVC** ☐ Pipe Lined

Invert Depth: **4.13** (ft.) Flow Characteristics: **None**

Deposits: ☒ None ☐ Mud ☐ Sludge ☐ Debris ☐ Grease

Infiltration: **None** Pipe Seal Cond: **Sound**
